espc:home report

1 Lindsay Avenue
SALTCOATS
KA21 5SQ
20/03/2024

Single Survey

survey report on:

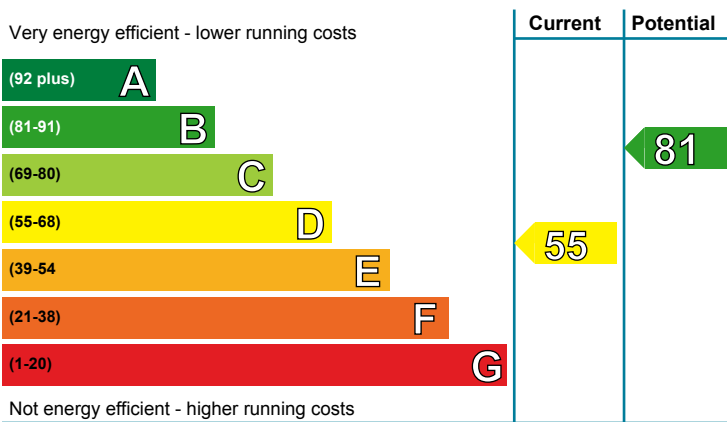
Energy Efficiency Rating

This graph shows the current efficiency of your home, taking into account both energy efficiency and fuel costs. The higher this rating, the lower your fuel bills are likely to be.

Your current rating is **band D (55)**. The average rating for EPCs in Scotland is **band D (61)**.

The potential rating shows the effect of undertaking all of the improvement measures listed within your recommendations report.

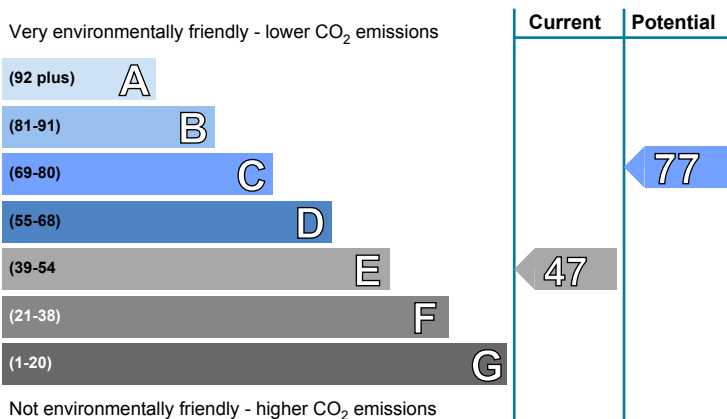
Environmental Impact (CO₂) Rating

This graph shows the effect of your home on the environment in terms of carbon dioxide (CO₂) emissions. The higher the rating, the less impact it has on the environment.
