survey report on:

Property address	9b South Crescent Road, Ardrossan, KA22 8DU
Customer	Mr D MacNicol
Customer address	
Prepared by	Walker Fraser Steele
Date of inspection	22nd April 2024

WALKER FRASER STEELE LLP CHARTERED SURVEYORS

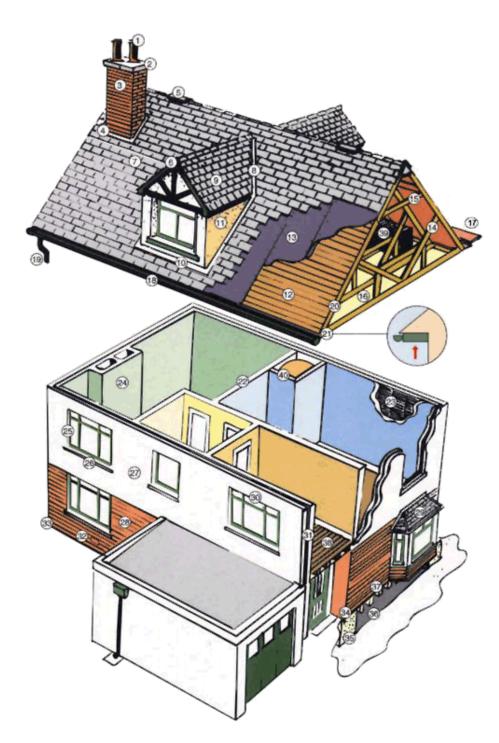
Sectional Diagram showing elements of a typical house

Reference may be made in this report to some or all of the above component parts of the property. This diagram may assist you in locating and understanding these items.

- 1) Chimney pots
- 2) Coping stone
- 3) Chimney head
- 4 Flashing
- 5) Ridge ventilation
- 6 Ridge board
- 7) Slates / tiles
- 8 Valley guttering
- 9 Dormer projection
- 10) Dormer flashing
- 11) Dormer cheeks
- (12) Sarking
- (13) Roof felt
- (14) Trusses
- (15) Collar
- (16) Insulation
- 17) Parapet gutter
- (18) Eaves guttering
- (19) Rainwater downpipe
- 20) Verge boards/skews
- 21) Soffit boards
- 22) Partition wall
- 23) Lath / plaster
- 24) Chimney breast
- (25) Window pointing
- 6) Window sills
- 27) Rendering
- 28) Brickwork / pointing
- 29) Bay window projection
- 30 Lintels
- (31) Cavity walls / wall ties
- 32) Subfloor ventilator
- 33) Damp proof course
- 34) Base course
- 35) Foundations
- (36) Solum
- 37) Floor joists
- 38 Floorboards
- 39) Water tank
- 40 Hot water tank
