# espc:home report

28 Snowdon Terrace  
Seamill  
West Kilbride  
KA23 9HN  
07/05/2024

# Single Survey

<b>Property address</b>	28 Snowdon Terrace, Seamill, West Kilbride, KA23 9HN
-------------------------	---

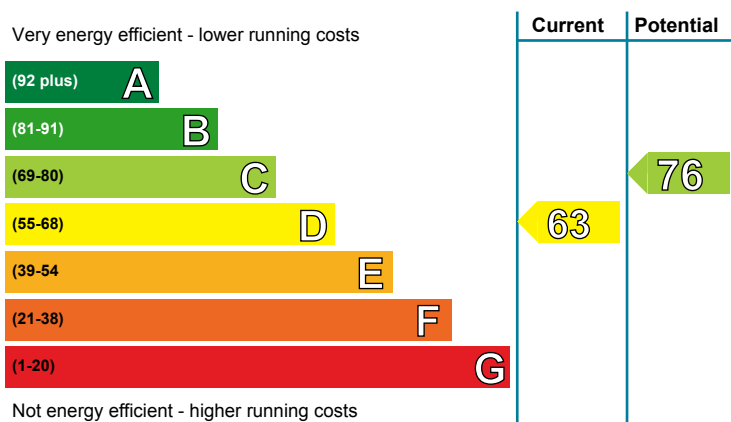
## Energy Efficiency Rating

This graph shows the current efficiency of your home, taking into account both energy efficiency and fuel costs. The higher this rating, the lower your fuel bills are likely to be.

Your current rating is **band D (63)**. The average rating for EPCs in Scotland is **band D (61)**.

The potential rating shows the effect of undertaking all of the improvement measures listed within your recommendations report.

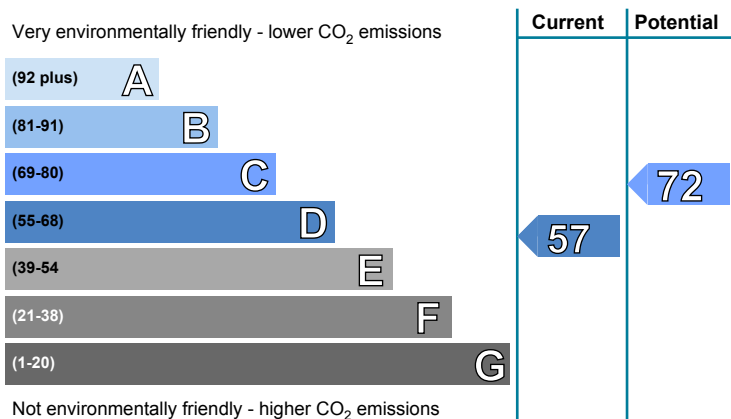
## Environmental Impact (CO<sub>2</sub>) Rating

This graph shows the effect of your home on the environment in terms of carbon dioxide (CO<sub>2</sub>) emissions. The higher the rating, the less impact it has on the environment.
